Attachment A

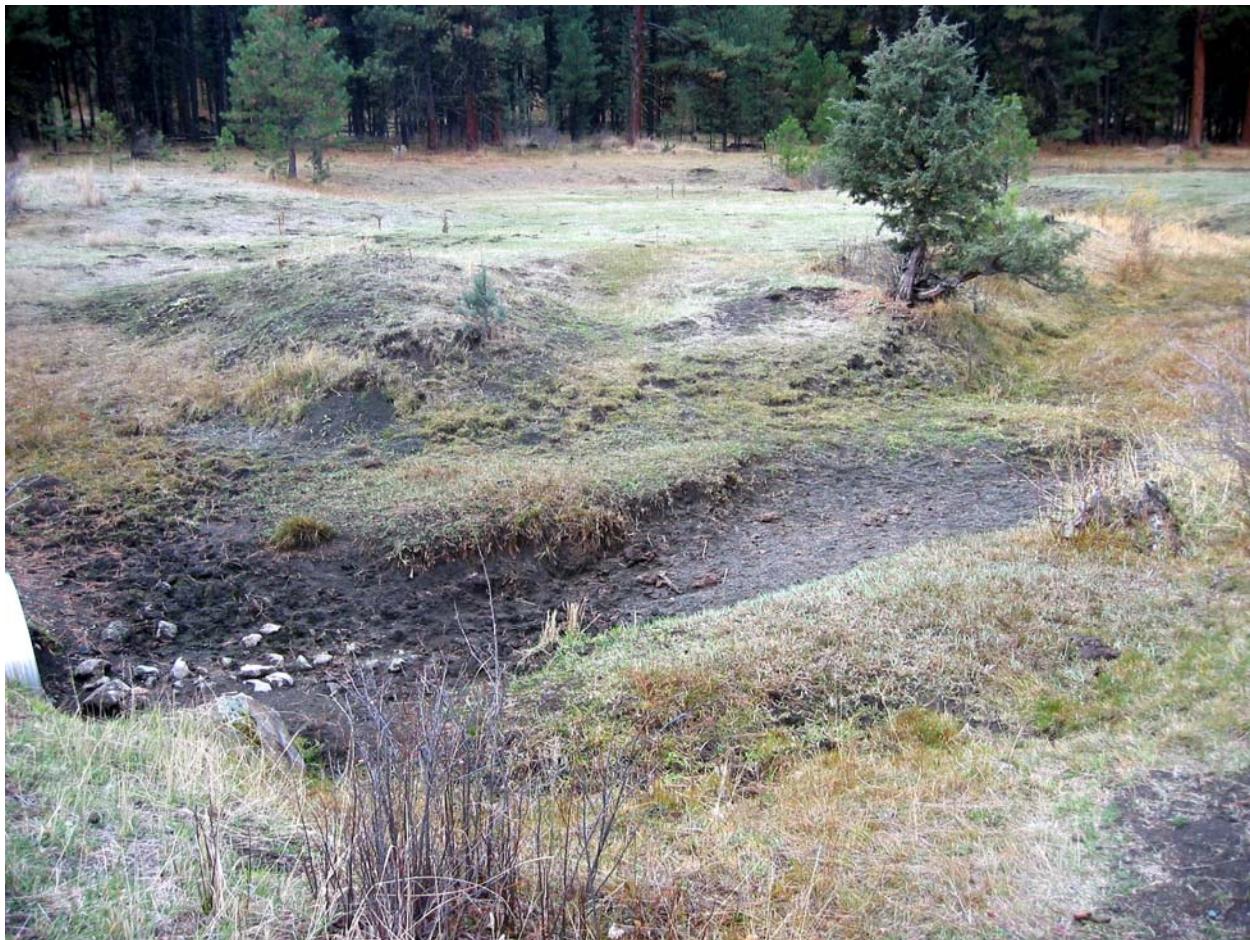
Photo 1. Heavily trampled and altered stream banks on the South Fork Murderers Creek, immediately downstream of 2480-209 road crossing of the creek in the MCA, October 20, 2007. As shown in the photo, bank alteration was much greater than 20%, as corroborated by the measurements of Christie, resulting in high levels of bank instability and degraded stream conditions. The dearth of deep-rooted vegetation on the banks, caused by grazing, together with the vulnerable stream bank soils, render the stream banks extremely susceptible to alteration by livestock grazing. The bank instability and bank alteration has contributed to the extremely high levels of fine sediment in the stream bottom visible in the photo. The high levels of fine sediment degrade steelhead habitats in a variety of ways that reduce the survival and production of steelhead.

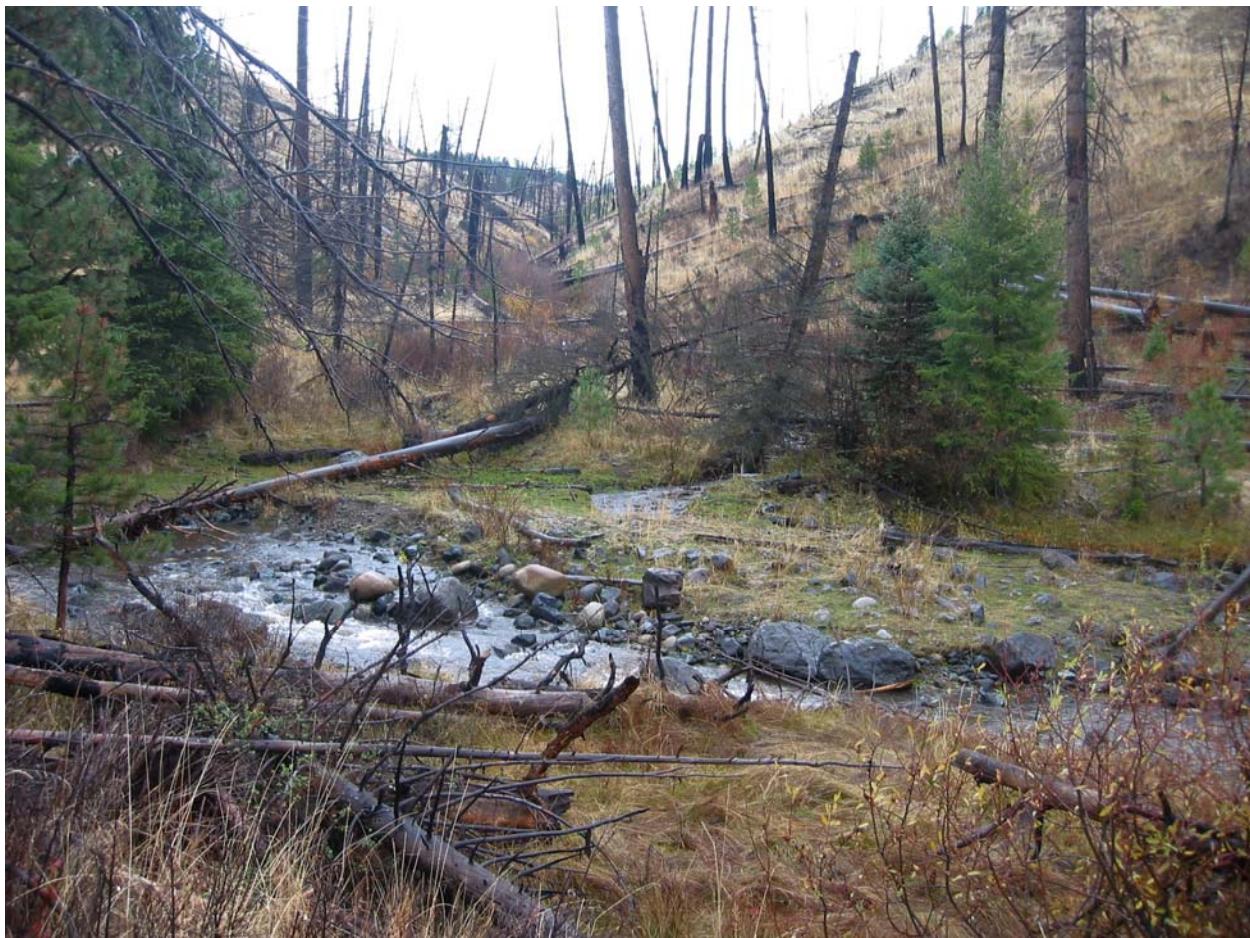
Photo 2. Another view of the same area as in Photo 1, heavily trampled and altered stream banks on the South Fork Murderers Creek, immediately downstream of 2480-209 road crossing in the MCA, October 20, 2007. Bank alteration was much greater than 20% in this area, as corroborated by the measurements of Christie, resulting in high levels of bank instability and degraded stream conditions. The dearth of deep-rooted vegetation on the banks, caused by grazing, together with the vulnerable stream bank soils, make the stream banks extremely susceptible to alteration by livestock grazing. The bank instability and bank alteration has contributed to the extremely high levels of fine sediment in the stream bottom visible in the photo. The high levels of fine sediment degrade steelhead habitats in a variety of ways that reduce the survival and production of steelhead.

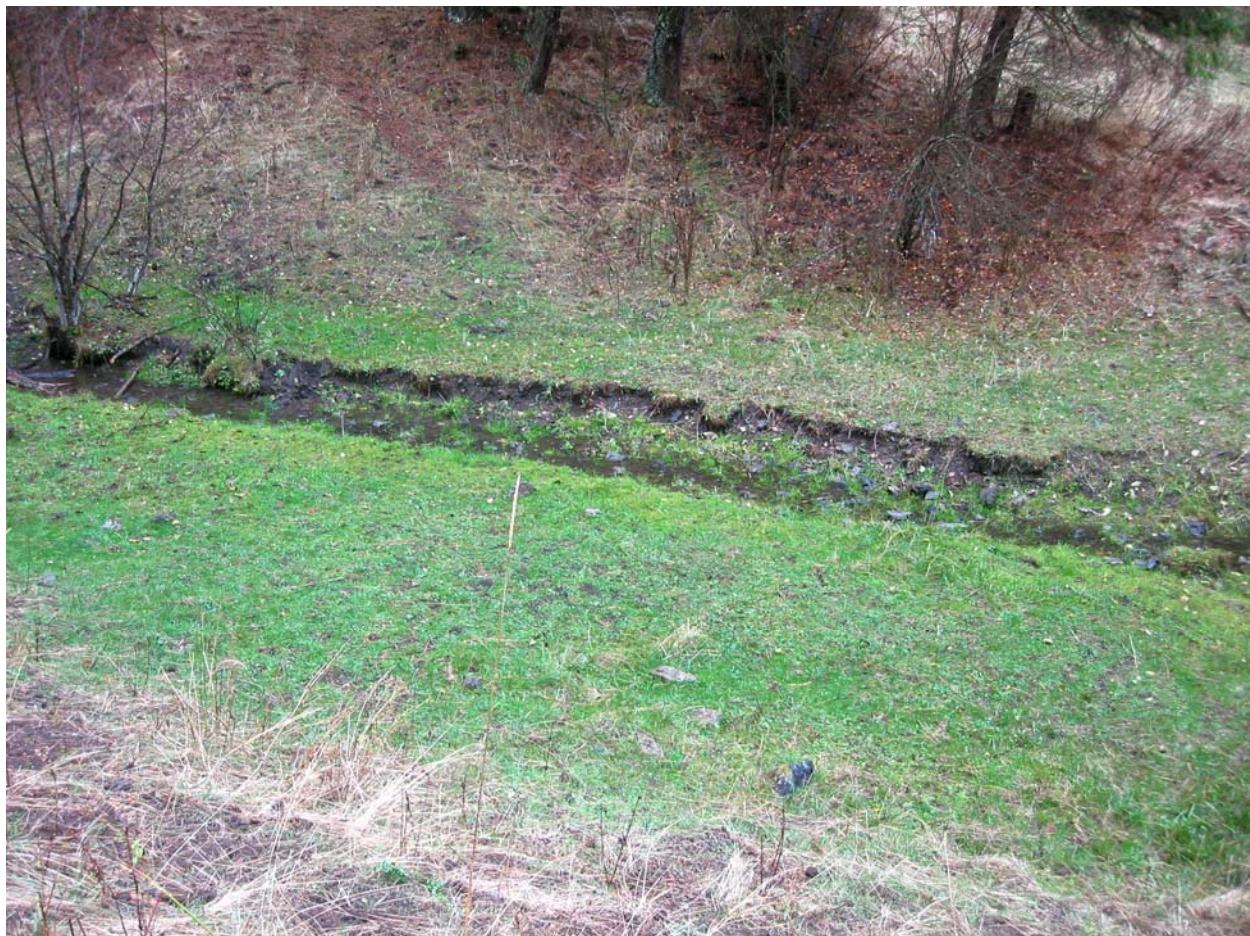
Photo 3. Heavily trampled and altered stream banks on Big Boulder Creek (foreground) and Wray Creek, just upstream of their confluence in the LMFA, October 19, 2007. As shown in the photo, bank alteration was much greater than 20%, resulting in high levels of bank instability and degraded stream conditions. The dearth of deep-rooted vegetation on the banks, caused by grazing, together with the vulnerable stream bank soils renders the stream banks extremely susceptible to alteration by livestock grazing. The bank instability and bank alteration have contributed to the extremely high width/depth ratio in this stream, which along with the loss of riparian vegetation from grazing, is elevating water temperature. High water temperatures are a pervasive problem afflicting steelhead habitat in streams draining the LMFA.

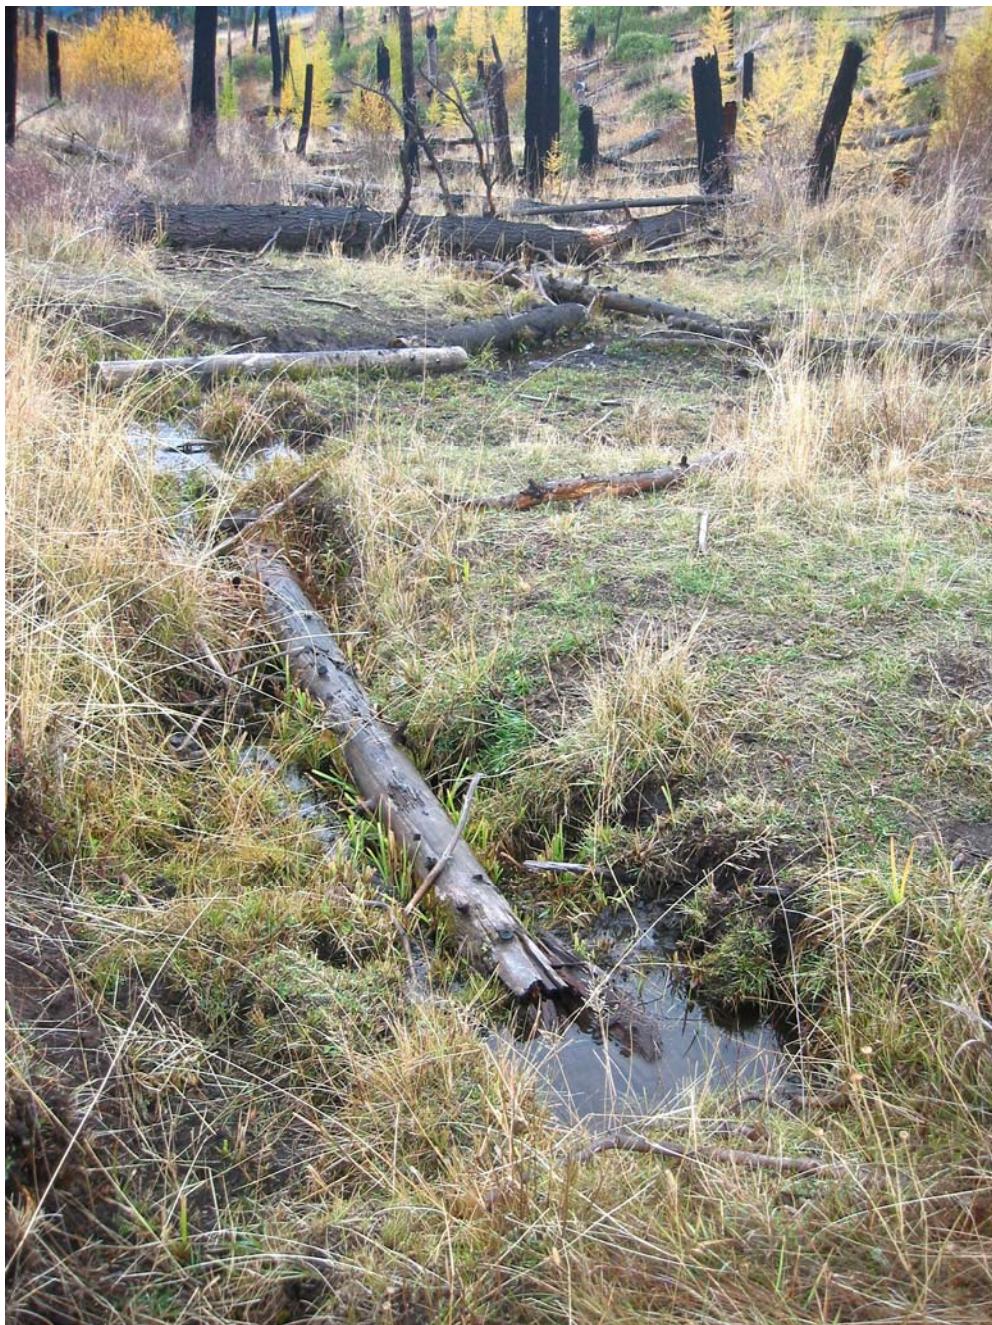
Photo 4. Heavily trampled and altered stream banks on Mosquito Creek in the LMFA, October 19, 2007. As shown in the photo, bank alteration was much greater than 20%, resulting in high levels of bank instability and degraded stream conditions. The dearth of deep-rooted vegetation on the banks, caused by grazing, together with the vulnerable stream bank soils renders the stream banks extremely susceptible to alteration by livestock grazing. The bank instability and bank alteration have contributed to the extremely high width/depth ratio in this stream, which along with the loss of riparian vegetation from grazing, is elevating water temperature. High water temperatures are a pervasive problem afflicting steelhead habitats in streams draining the LMFA.

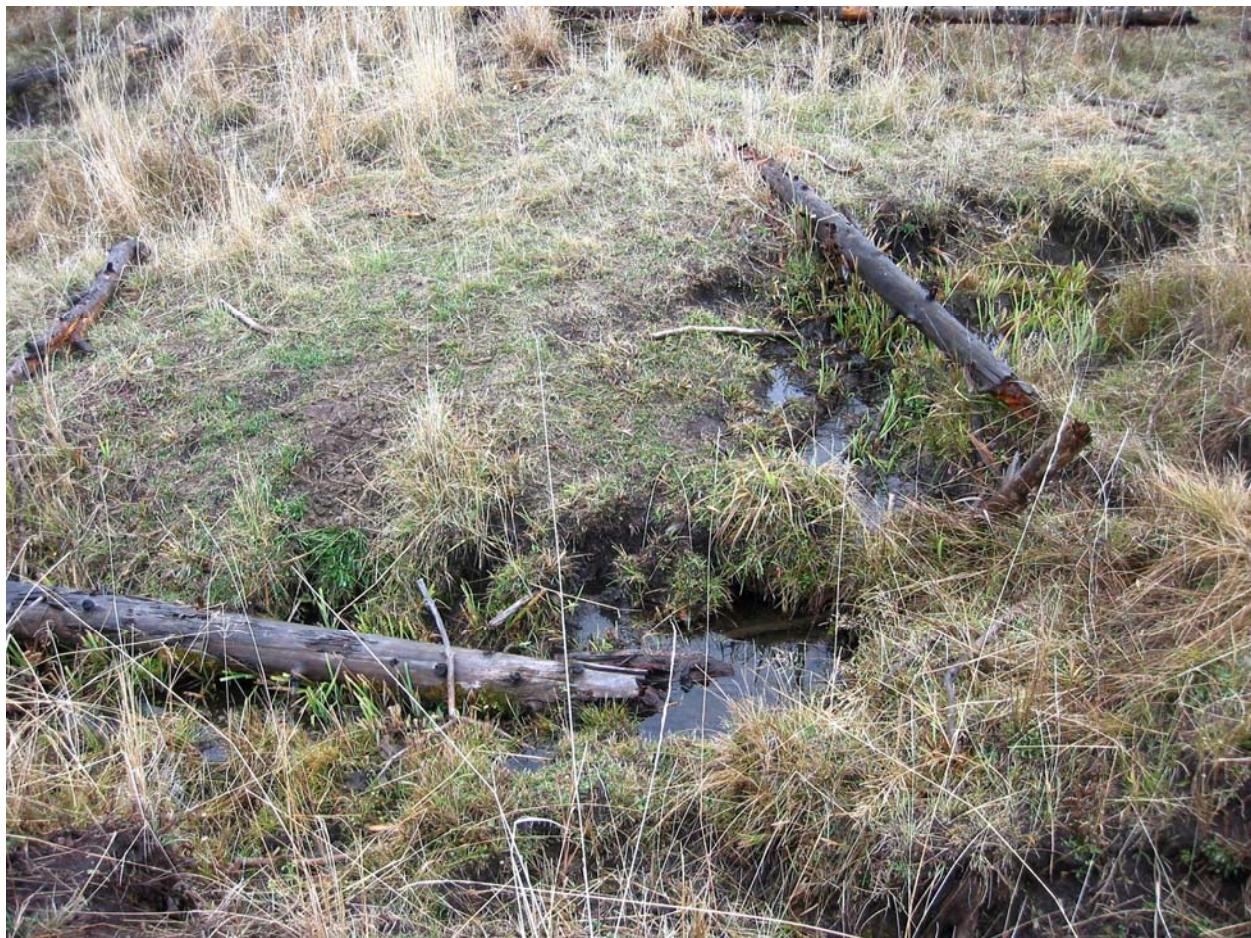
Photo 5. Heavily trampled and altered stream banks on Coyote Creek in the LMFA, October 19, 2007. As shown in the photo, bank alteration was much greater than 20%, resulting in high levels of bank instability and degraded stream conditions. The dearth of deep-rooted vegetation on the banks, caused by grazing, together with the vulnerable stream bank soils renders the stream banks extremely susceptible to alteration by livestock grazing.

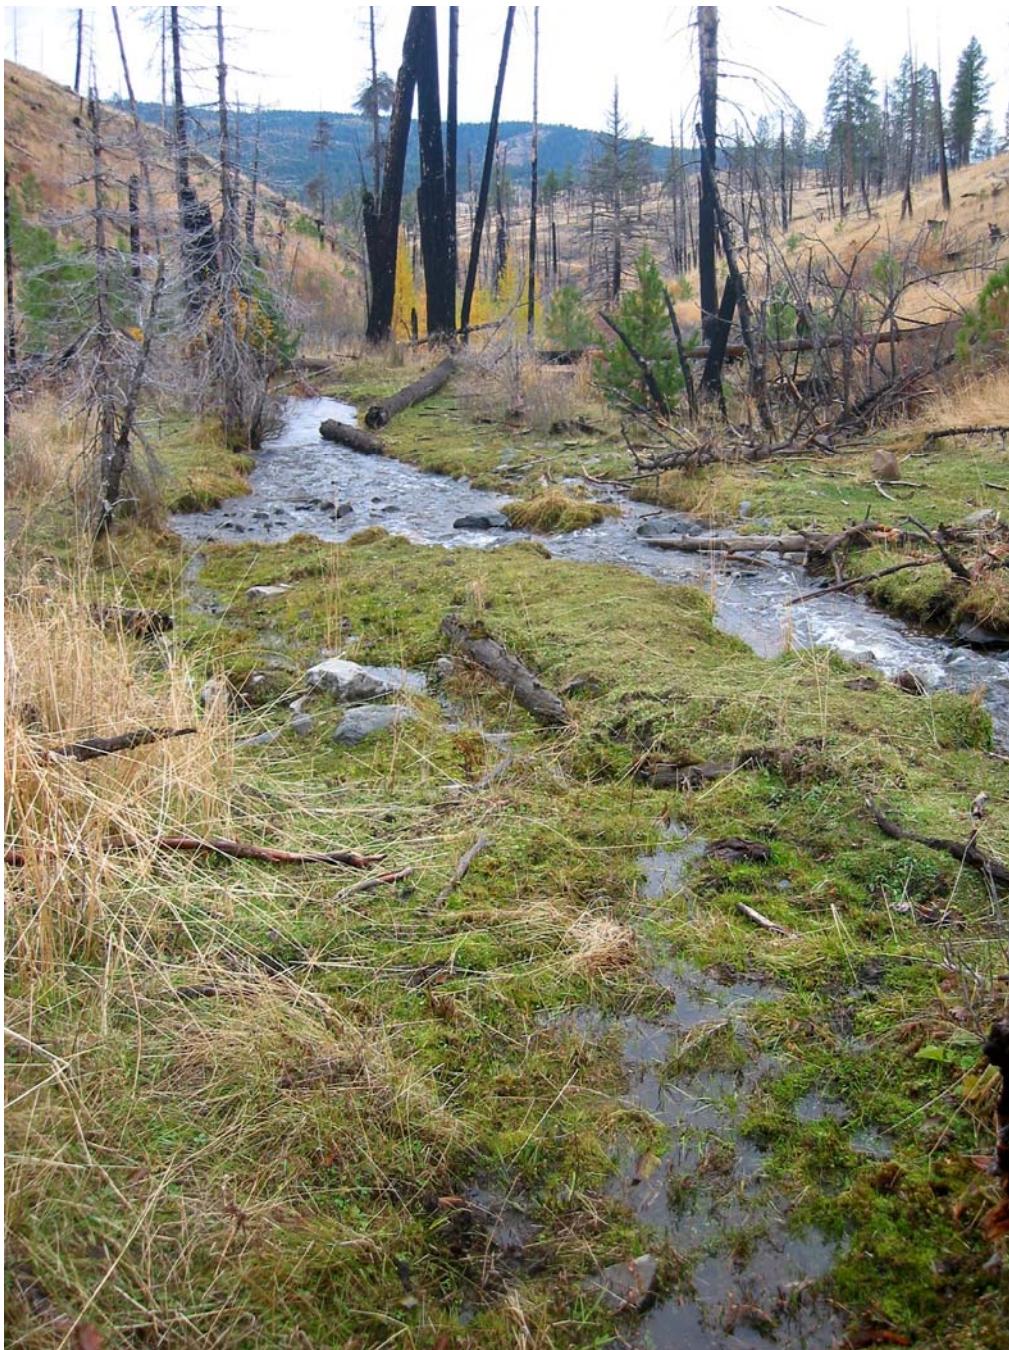
Photo 6. Another view of the heavily trampled and altered stream banks on Coyote Creek in the LMFA, October 19, 2007. Photo was taken near the same location as Photo 5. As shown in the photo, bank alteration was much greater than 20%, resulting in high levels of bank instability and degraded stream conditions. The dearth of deep-rooted vegetation on the banks, caused by grazing, together with the vulnerable stream bank soils renders the stream banks extremely susceptible to alteration by livestock grazing.

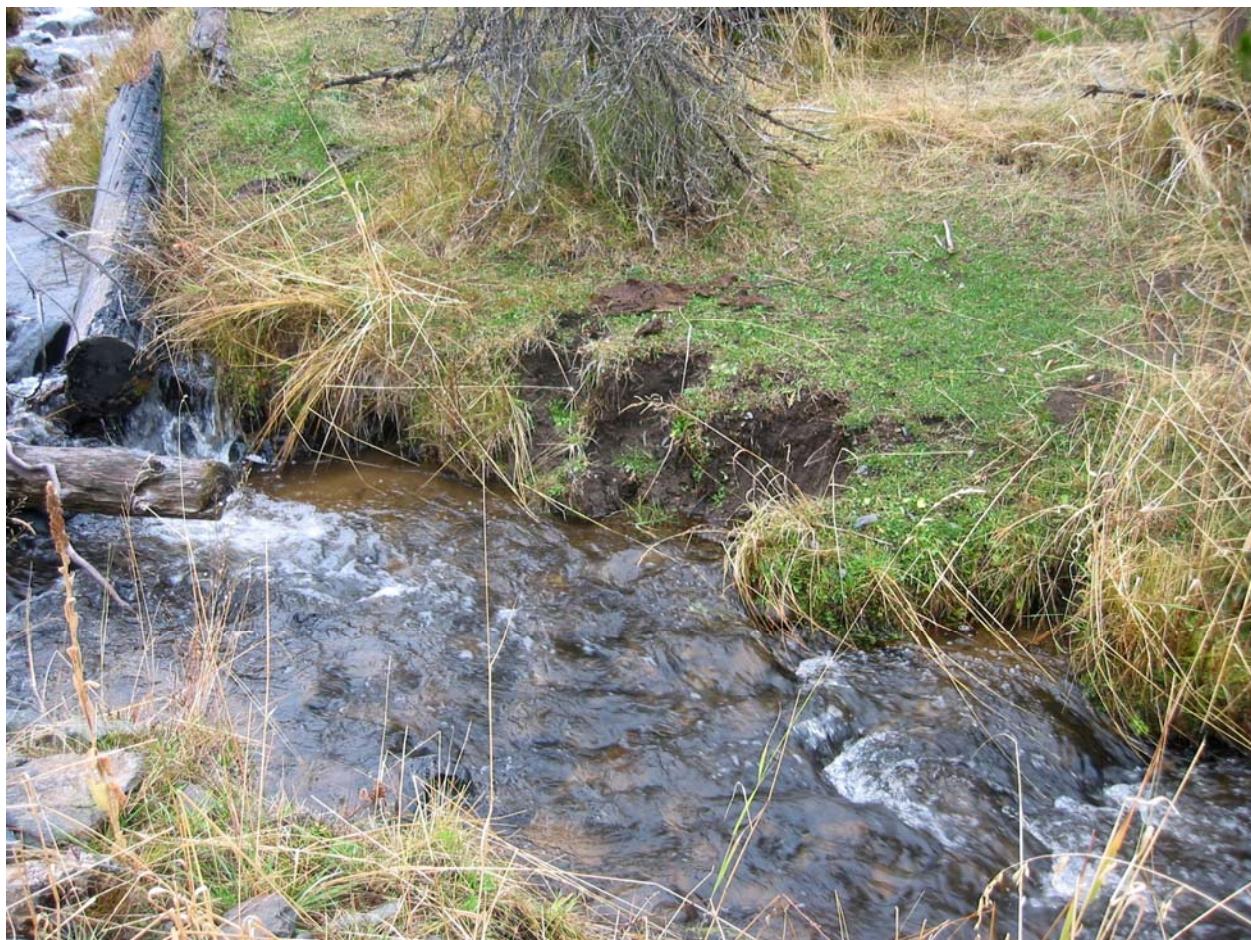
Photo 7. Heavily trampled and altered stream banks of Wray Creek in the LMFA, October 19, 2007. As shown in the photo, bank alteration was much greater than 20%, resulting in high levels of bank instability and degraded stream conditions. The dearth of deep-rooted vegetation on the banks, caused by grazing, together with the vulnerable stream bank soils renders the stream banks extremely susceptible to alteration by livestock grazing. The bank instability and bank alteration have contributed to the extremely high width/depth ratio in this stream, which along with the loss of riparian vegetation from grazing, is elevating water temperature. High water temperatures are a pervasive problem in streams draining the LMFA.
