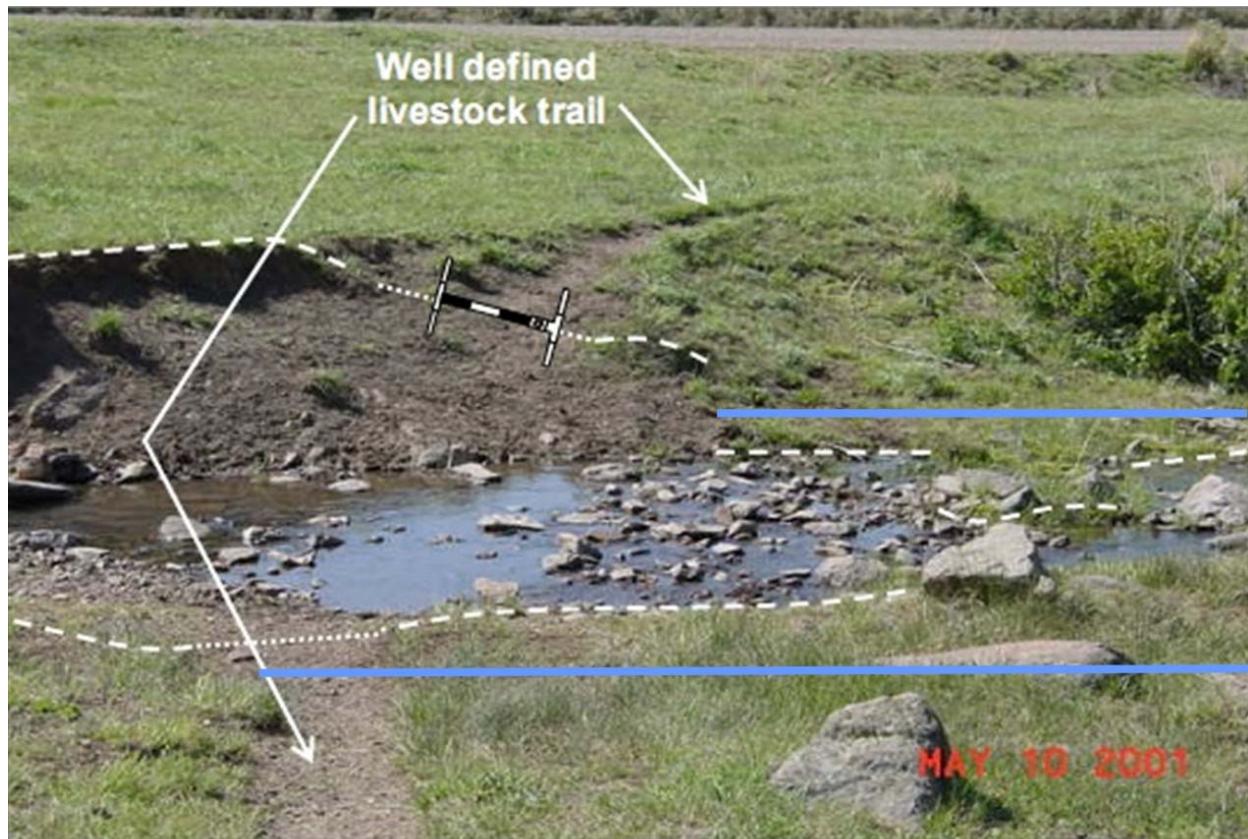
**Figure 3**—while livestock trails are not considered part of the greenline; they are considered for streambank alteration. The frame is placed at the point of the toe on a line that joins the greenline on either side of the trail. The example above shows the frame on a livestock trail that has been used during the current grazing season. Since all five lines intersect streambank alteration record five.

The figure and caption above are from USFS bank monitoring guidance (Burton et al, 2007). The blue lines, which I have added to the figure, show sections of the “greenline” used in bank monitoring that are likely to be submerged and subject to erosion and deposition during subsequent high flows. This figure and caption also clearly demonstrate that livestock trails are to be included in measurements of bank alteration. .

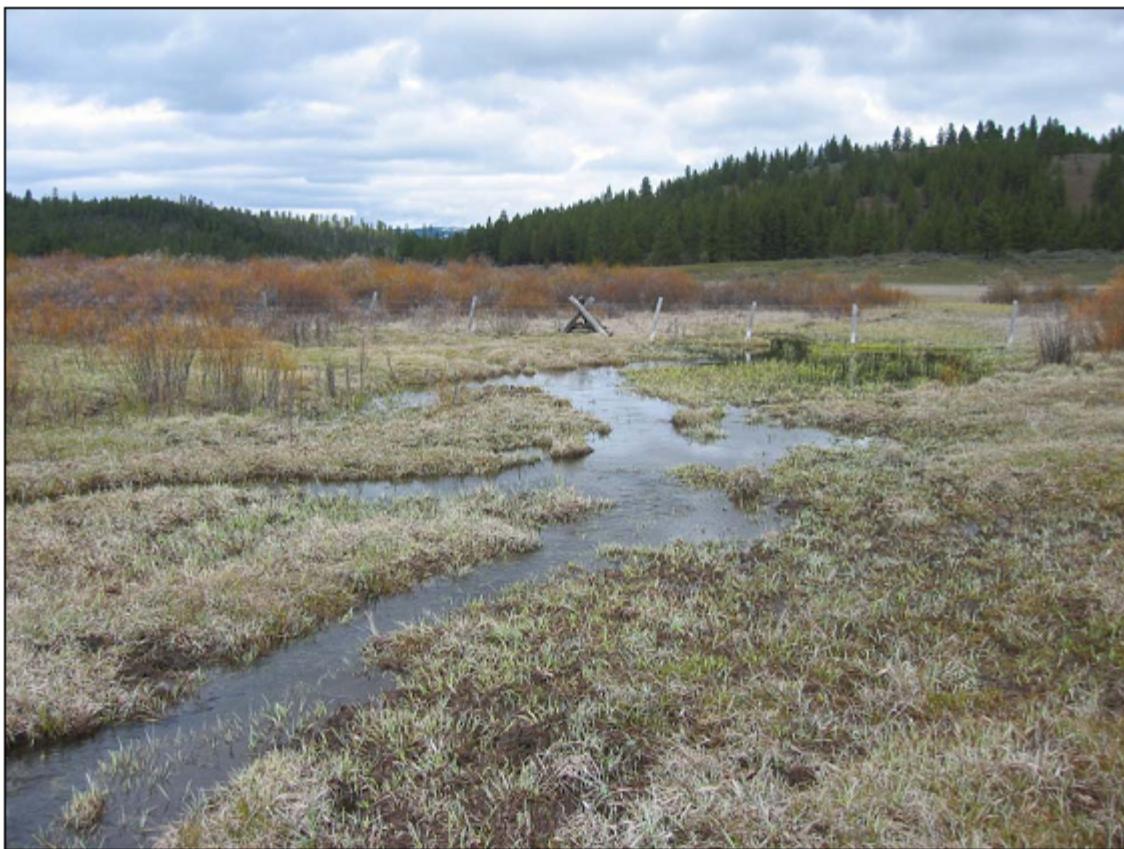
South Fork Murderers Creek, Murderers Creek Allotment, Malheur National Forest, April 2003. View of the exclosure from national forest land. Ungrazed area is behind the fence in the photo. Notice the far greater abundance and height of willows within the exclosure compared to the grazed area on national forest land.

This photo was included in my declaration in Ore. Natural Desert Ass'n v. U.S. Forest Serv., N.03-281-HA (D.Or.) and included in the Second Stout Declaration Attachment 1, p. 7

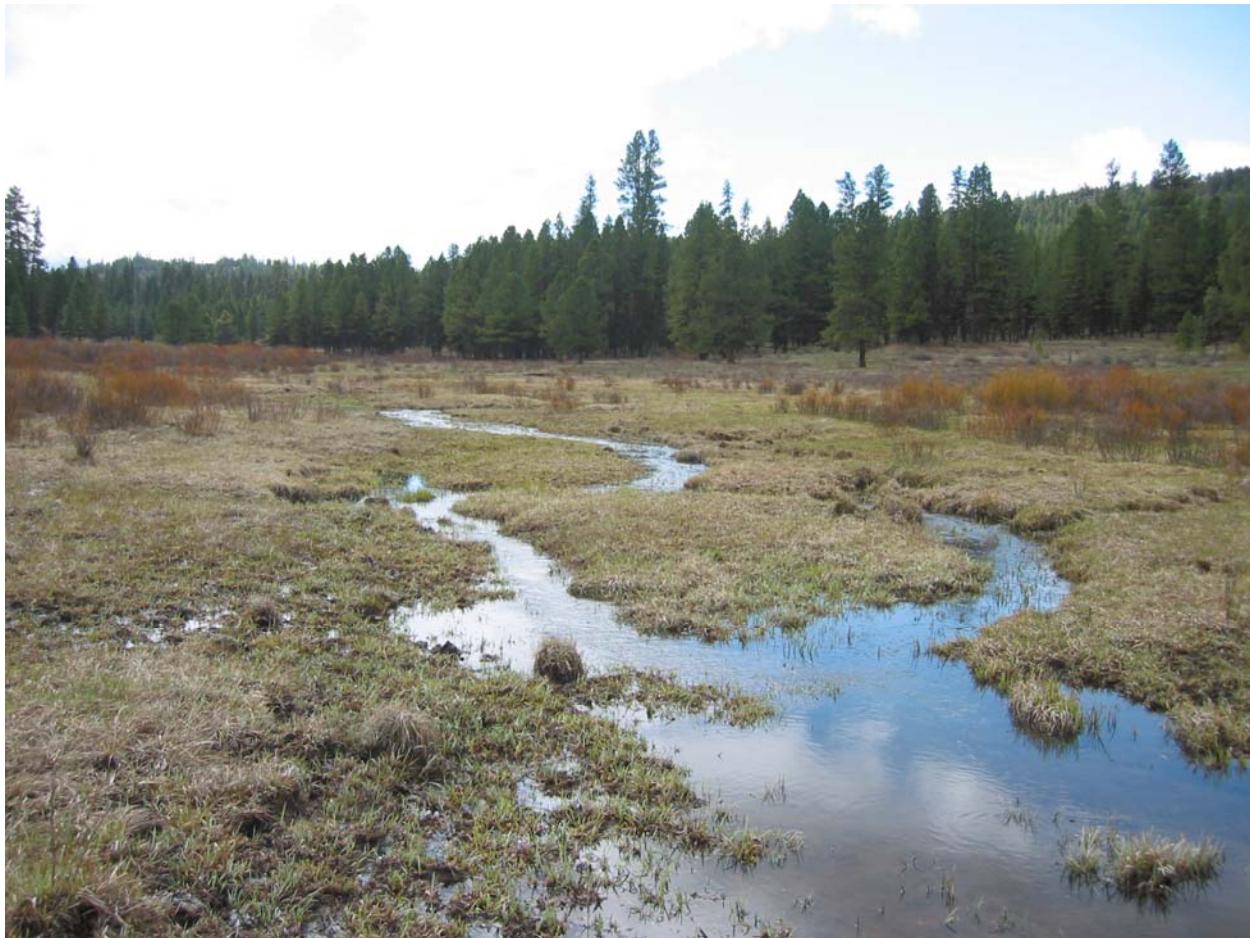
Another view of the South Fork Murderers Creek John Young Meadow, Murderers Creek Allotment, Malheur National Forest, April 2003. This photo is taken looking upstream from the exclosure and the photo was taken from the same general area as the previous photo, which was included in the Second Stout Declaration's Attachment 1 (p. 7 of 50). This photo as well as the previous photo shows that: a) there is a much lower abundance and height willows on this reach of the South Fork Murderers Creek in comparison with that inside the exclosure, as shown in the previous photo; b) the previous photo does not provide a misleading picture of stream conditions as incorrectly purported in the Memo (p. 18); c) dense willows do not line this reach of the stream as incorrectly purported in the Memo (p. 18) and the Second Stout Declaration (p. 5, ¶ 14); and, d) the vegetation conditions in this reach upstream of the exclosure in John Young Meadow do not impede or restrict the movement of livestock, elk, or horses causing them to concentrate movement along the fence line near the exclosure, as purported in the Second Stout Declaration's Attachment 1 (p. 8 of 50). These photos of conditions existing along this stream reach show that the photo and information in the Second Stout Declaration's Attachment 1 (p. 8 of 50) is potentially misleading because it only provides an oblique view of the meadow vegetation, rather than conditions along the stream, and the stream is not lined with a dense stand of sizable willows.
