Attachment A

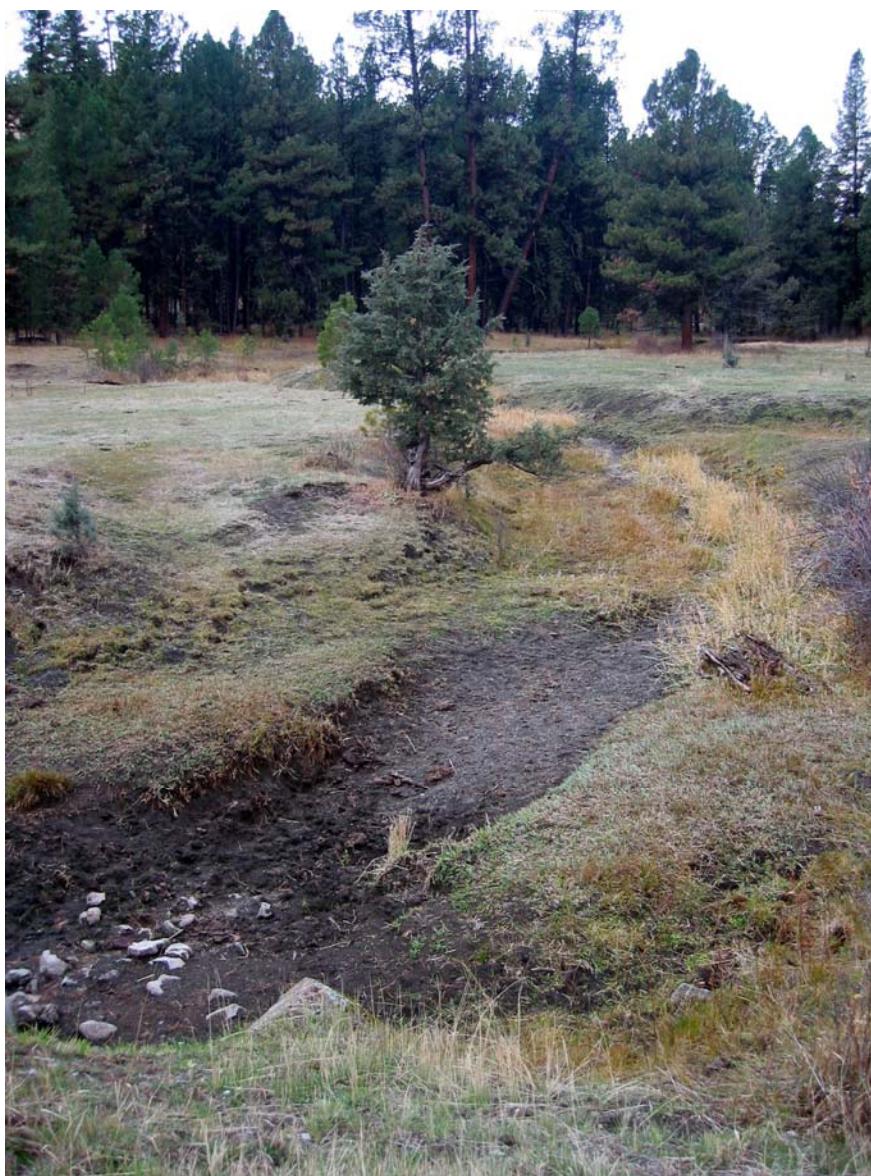
Photo 1. Heavily trampled and altered stream banks on the South Fork Murderers Creek, immediately downstream of 2480-209 road crossing of the creek in the MCA, October 20, 2007. As shown in the photo, bank alteration was much greater than 20%, as corroborated by the measurements of Christie, resulting in high levels of bank instability and degraded stream conditions. The dearth of deep-rooted vegetation on the banks, caused by grazing, together with the vulnerable stream bank soils, render the stream banks extremely susceptible to alteration by livestock grazing. The bank instability and bank alteration has contributed to the extremely high levels of fine sediment in the stream bottom visible in the photo. The high levels of fine sediment degrade steelhead habitats in a variety of ways that reduce the survival and production of steelhead.
